RADION receiver SD

B810

en Release notes

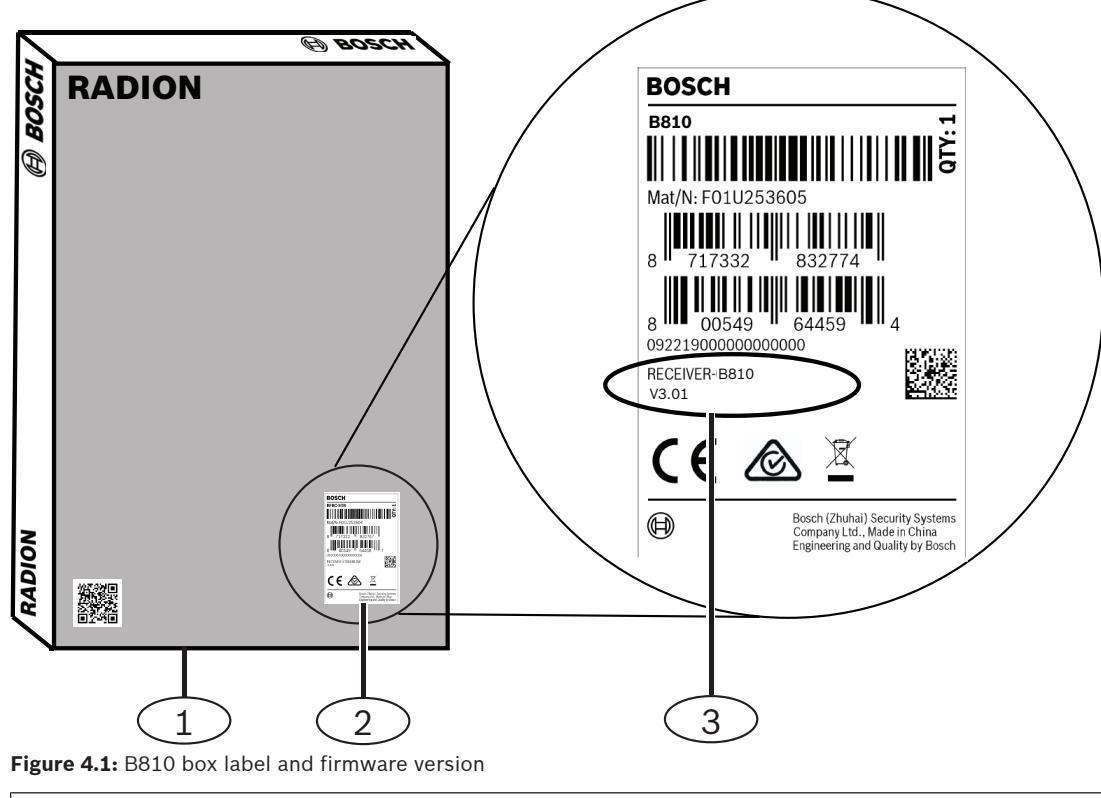
Callout — Description	
1 — Receiver box	
2 — Receiver box label	
3 — Receiver firmware version

The receiver and the receiver's box show the original firmware version installed during manufacturing. You can use the RPS diagnostics feature to determine the B810 firmware version at any time. The B810 must be connected to a compatible control panel. Refer to the figures to locate and determine your receiver's original firmware version.

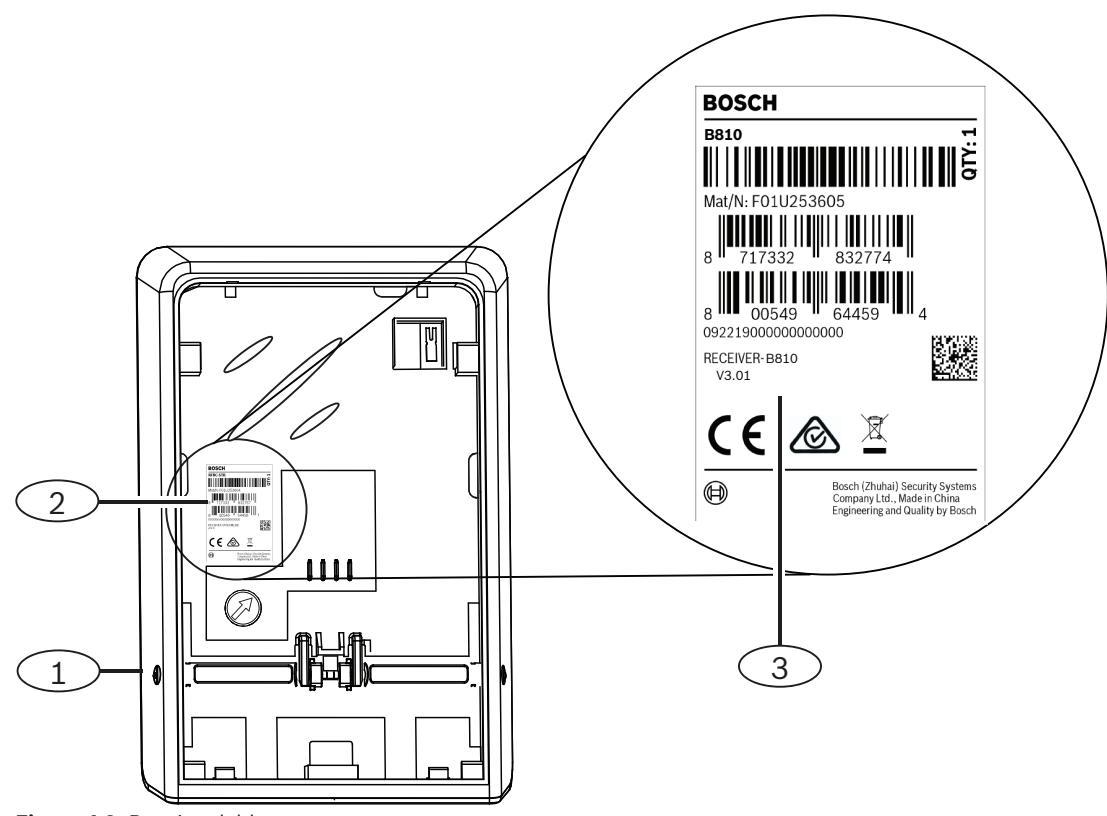
Figure 4.2: Receiver lable

Callout — Description		
1 — Receiver		
2 — Receiver label		
3 — Receiver firmware version
